## Leadville Historic Preservation Commission Regular Meeting Agenda

### **STAFF REPORT**

Ian Munoz & Sophie Riese 139 E. 9<sup>th</sup> Street Leadville, Colorado 970-631-2927 iam@ianmunoz.com Architect's Project Number: 21-008

**Property:** Munoz – Riese Residence 139 E. 9<sup>th</sup> Street, Leadville, CO 80461

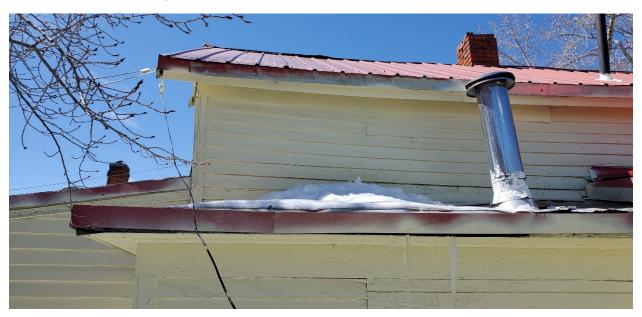
Figure 15: Corrugated Metal Roof Over Original 2-Story House

**Recommendation:** The existing metal roof is in poor to fair condition, depending on the location. As noted from the cursory historic research, metal is not the historic roofing material over the original house. Restoration of the historic material is not required, and metal roofs do offer longevity, durability,

and fire-resistance. Although the roof may be serviceable for several more years, when the major renovation project is undertaken our team would recommend that the existing roofing be removed, rigid insulation added on top of the roof sheathing to increase energy performance of the house. The Owner and Architect should determine an appropriate roofing material for replacement at that time. The addition of snow guards and gutters and downspouts should also be discussed, and the Owners can determine if a snowmelt system is desired for ease of maintenance.

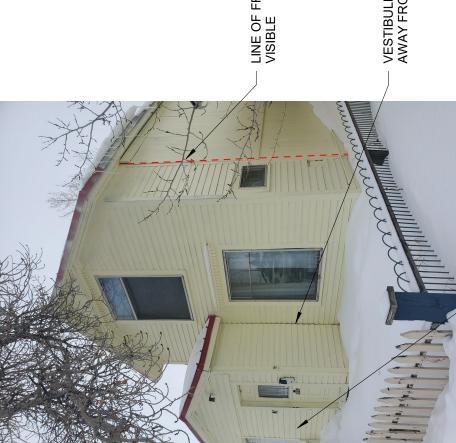
LINE OF FRONT ADDITION VISIBLE

VESTIBULE SEPARATING AWAY FROM MAIN HOUSE

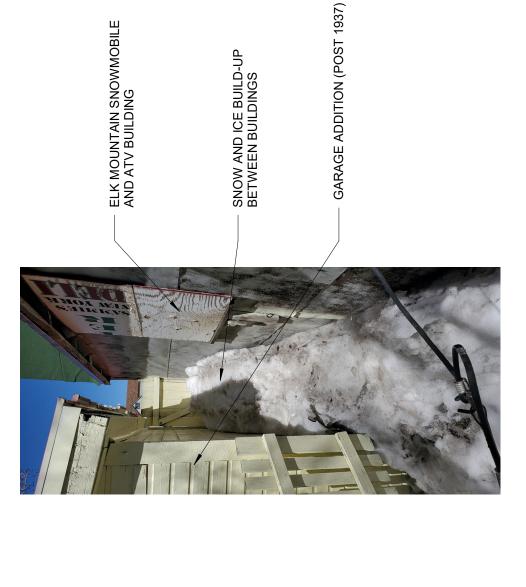
1937 EAST ADDITION

GARAGE ADDITION SHIFTING AWAY FROM MAIN HOUSE
